**FORMER AVEC POWER PLANT
ANVIK, ALASKA**

PHASE I ENVIRONMENTAL SITE ASSESSMENT

OCTOBER 2007

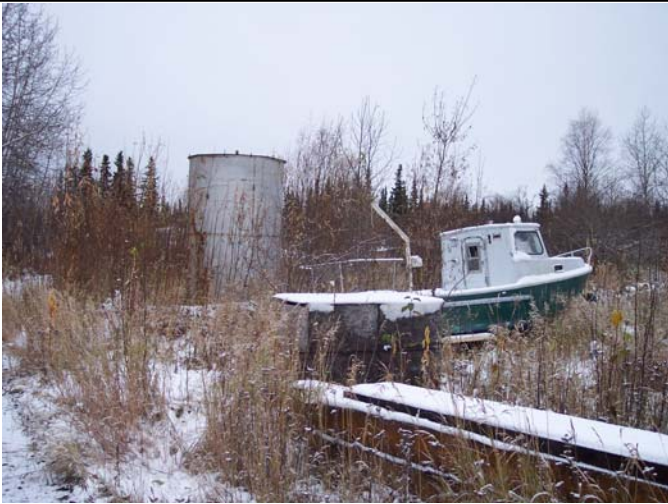
The property was accessed from Old School Road. The subject property consisted of a vacant piece of land that was formerly used as a fuel storage area, and contained a 6,000-gallon fuel tank located inside an unlined containment basin (Photograph 1 in appendix A). The containment basin was constructed of sandbags and no liner was evident. The tank appeared to be empty and was located on wooden planks which formed a support foundation. The property was covered with low vegetation. Items noted on the subject property included a plywood container used for storage, a boat, a metal pipe, steel I-beams, and a metal frame. To the south of the fuel tank was a pile of pipe that may have been associated with the pipeline that was historically used to fuel the tank farm (Photograph 2 in Appendix A). The grounds surface was partially obscured by approximately 1 inch of snow. The area beneath the storage tank appeared to possibly have been stained, but no hydrocarbon odors were observed (Photograph 3 in Appendix A). No staining or obvious signs of stressed vegetation (except as described in the next paragraph) were visible on the subject property, but the ground surface was frozen and partially covered with snow, and all of the vegetation on site had died back for the winter.

Photograph 1 – Subject Property, Facing South

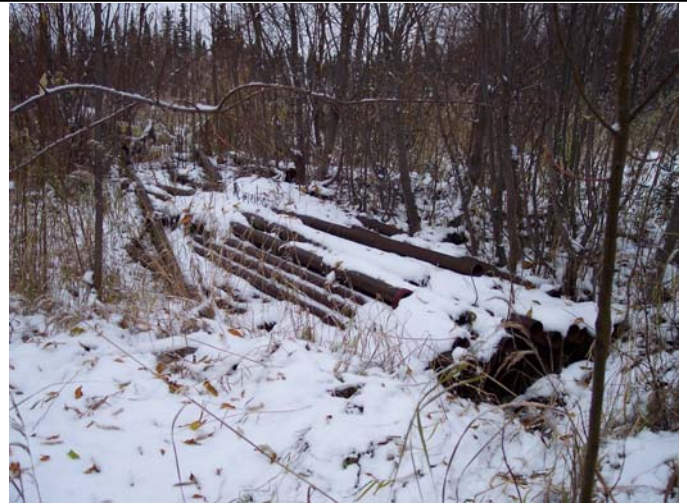
Photograph 2 – Pipe, South of the Fuel Tank, Looking South

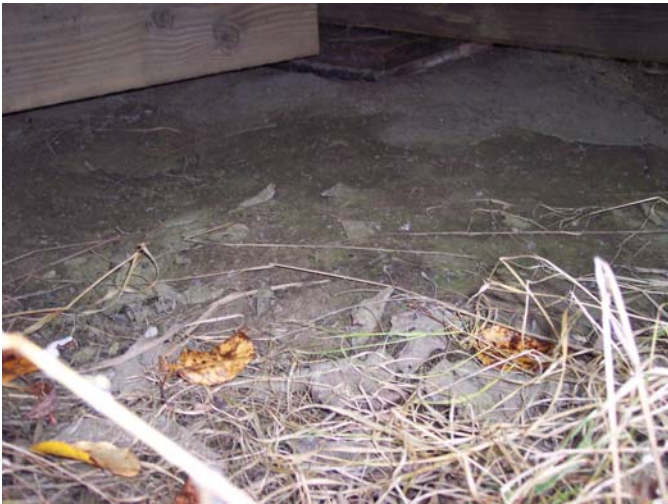
Photograph 3 – Ground Surface Beneath Fuel Tank

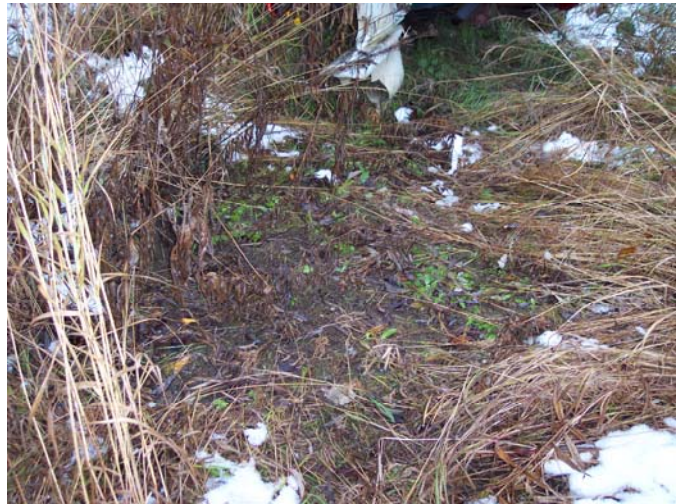
During the course of our field activities, freezing rain melted a portion of the snow cover and revealed two areas of vegetation that appeared to be stressed and possibly stained, to the east and north of the boat that was stored on the property (Photographs 4 and 5 in Appendix A). Shallow soil borings were advanced to a depth of 2 feet in these areas. No hydrocarbon odors were observed and field screening results did not indicate the presence of elevated hydrocarbon vapors in these areas.

Photograph 4 – Possible Stain, East of Boat

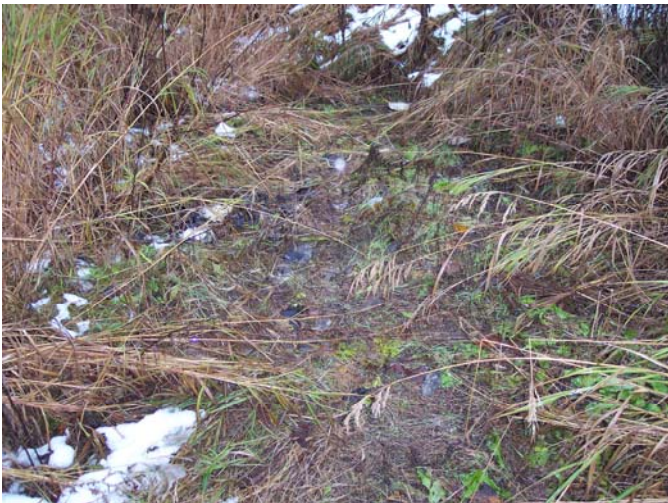
Photograph 5 – Possible Stain, North of Boat

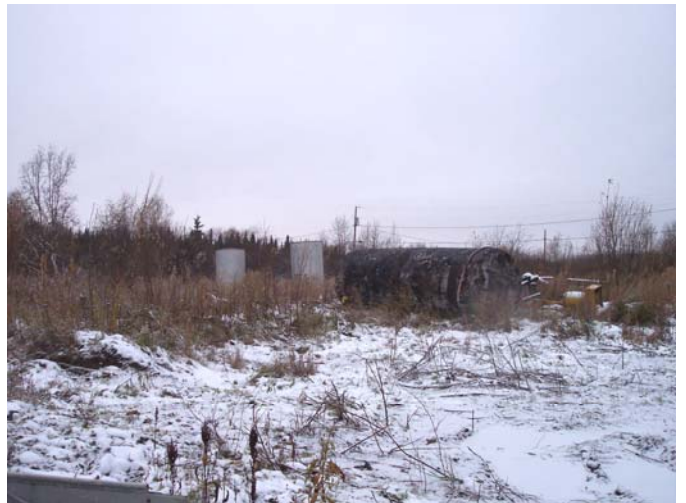
backhaul out of the village. Several large storage tanks were present on this lot (Photographs 6 in Appendix A) and this site is a contaminated site listed in the ADEC database. Items noted on this lot included junked snow machines, a refrigerator, a freezer, metal tubing and piping, broken equipment, and old boats (Photographs 7 and 8 in Appendix A). In addition many large connex containers are stored on this lot (Photograph 9 in Appendix A). The lot across Old School Road to the east contained a bulldozer in disrepair, construction materials, and a cache (Photograph 10 in Appendix A).

Photograph 6 – Neighboring Property to the West, Looking West

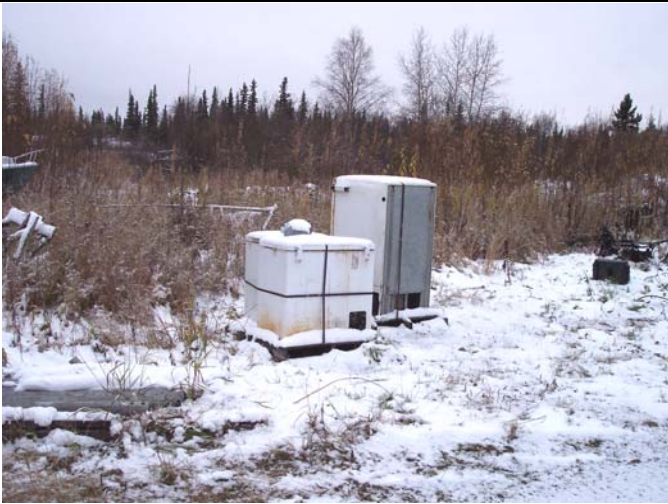
Photograph 7 – Neighboring Lot to the West, Looking South

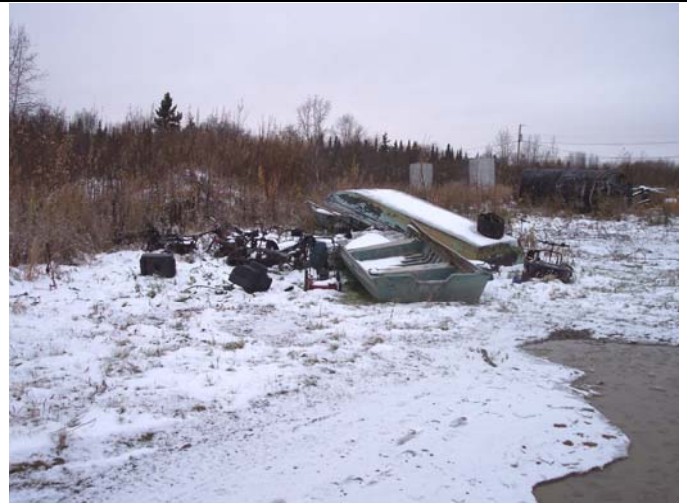
Photograph 8 – Neighboring Lot to the West, Looking South

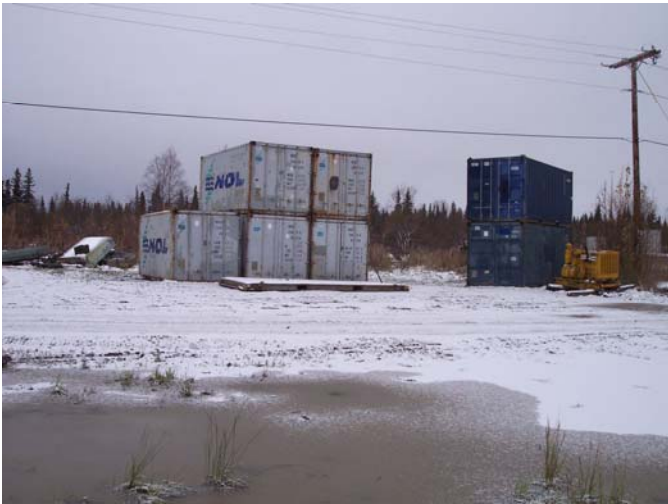
Photograph 9 – Neighboring Lot to the West, Looking South

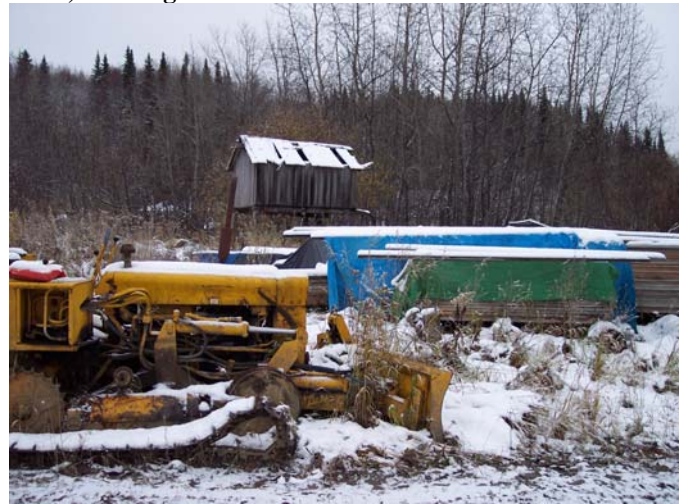
Photograph 10 – Neighboring Lot Across Old School Road to the East, Looking East
