**FORMER AVEC POWER PLANT
ANVIK, ALASKA**

PHASE I ENVIRONMENTAL SITE ASSESSMENT

OCTOBER 2007

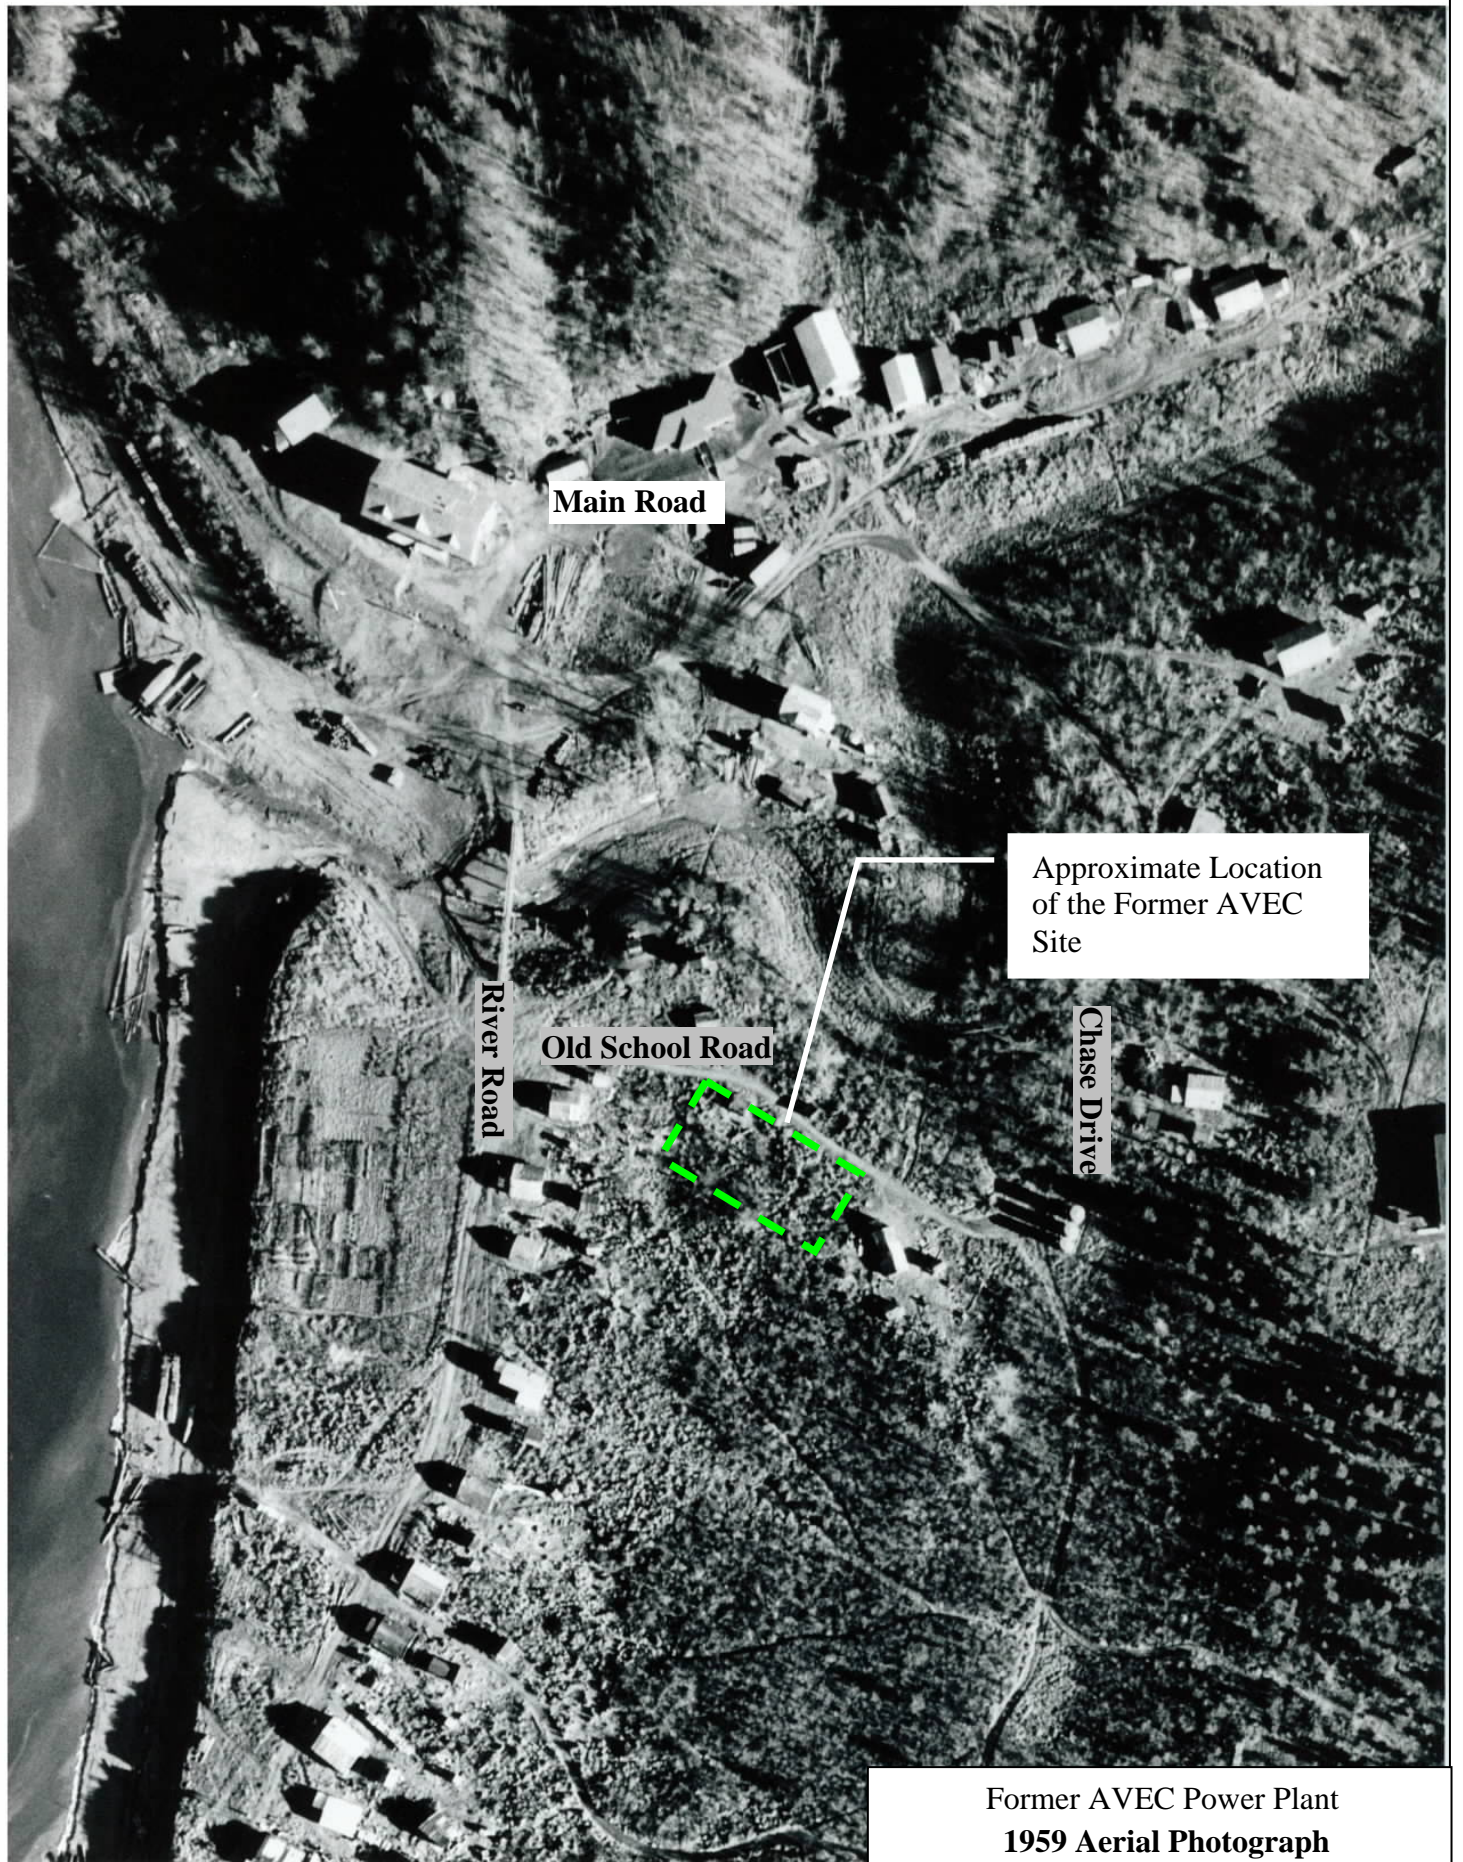
Former AVEC Power Plant 1959 Aerial Photograph		
BGES, INC.	October 2007	Figure 2

The 1959 aerial photograph, included as Figure 2, shows the subject property prior to the installation of the AVEC generator building and tank farm. The subject property appears to be covered with low vegetation. A small structure is located in the northern portion of the subject property and several small square objects are located to the north of the property. What appear to be residential structures are located to the north of the subject property, across old school road to the east of the subject property, and along River Road to the west. A bridge is located over the slough to the east of the subject property, and many residential and commercial structures are present along Main Road. The riverfront to the north of the subject property appears to be used for community farming. Three large storage tanks associated with the school tank farm are located to the south of the subject property. What appears to be a rectangular residential structure is located to the south of the subject property.

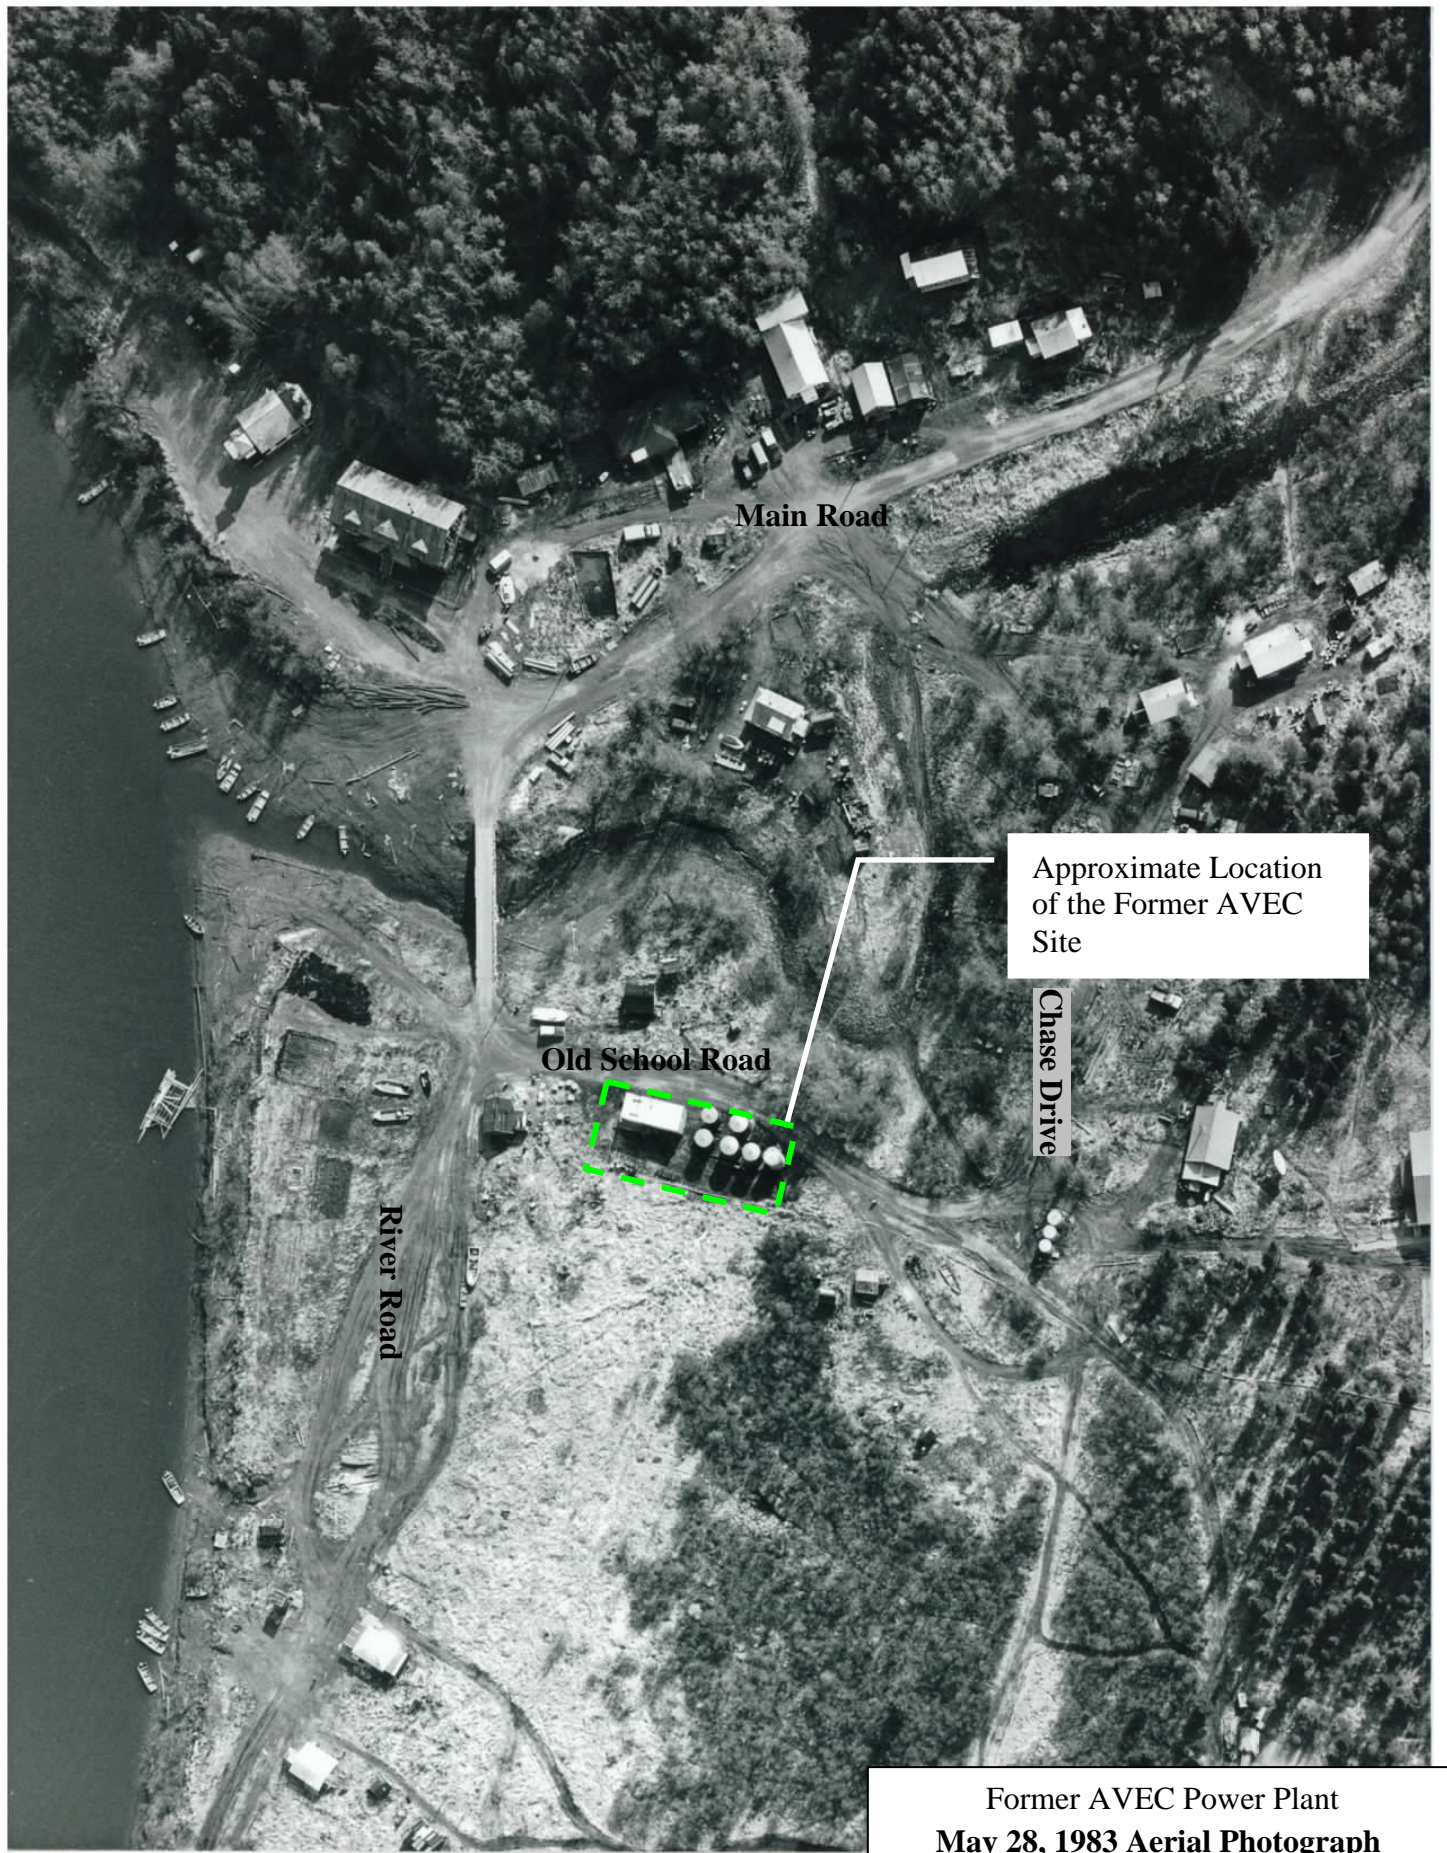
Former AVEC Power Plant May 28, 1983 Aerial Photograph		
BGES, INC.	October 2007	Figure 3

The May 28, 1983 aerial photograph, included as Figure 3, shows the subject property as being fully developed and actively used as the AVEC power plant. Six large tanks are located in the southern portion of the property. To the north of the tank farm is a generator building. To the west of the generator building are what appear to be several 55-gallon drums, and what appear to be many more drums stacked on their sides. To the north of the subject property are several cylindrical objects that appear to be larger than 55 gallon drums. The surrounding area is similar to the 1959 and 1972 aerial photographs, except that very few buildings remain on River Road near the riverfront. In addition, the area to the west of the subject property appears to have had some of the vegetation removed and be slightly graded. The riverfront area to the north of the subject property still appears to be used for community farming. The tanks associated with the old school are still visible to the south of the subject property, but the rectangular residential structure to the south of the subject property is no longer visible. Two smaller structures are visible in this area. What appears to be a residential structure is located to the southeast of the tanks.

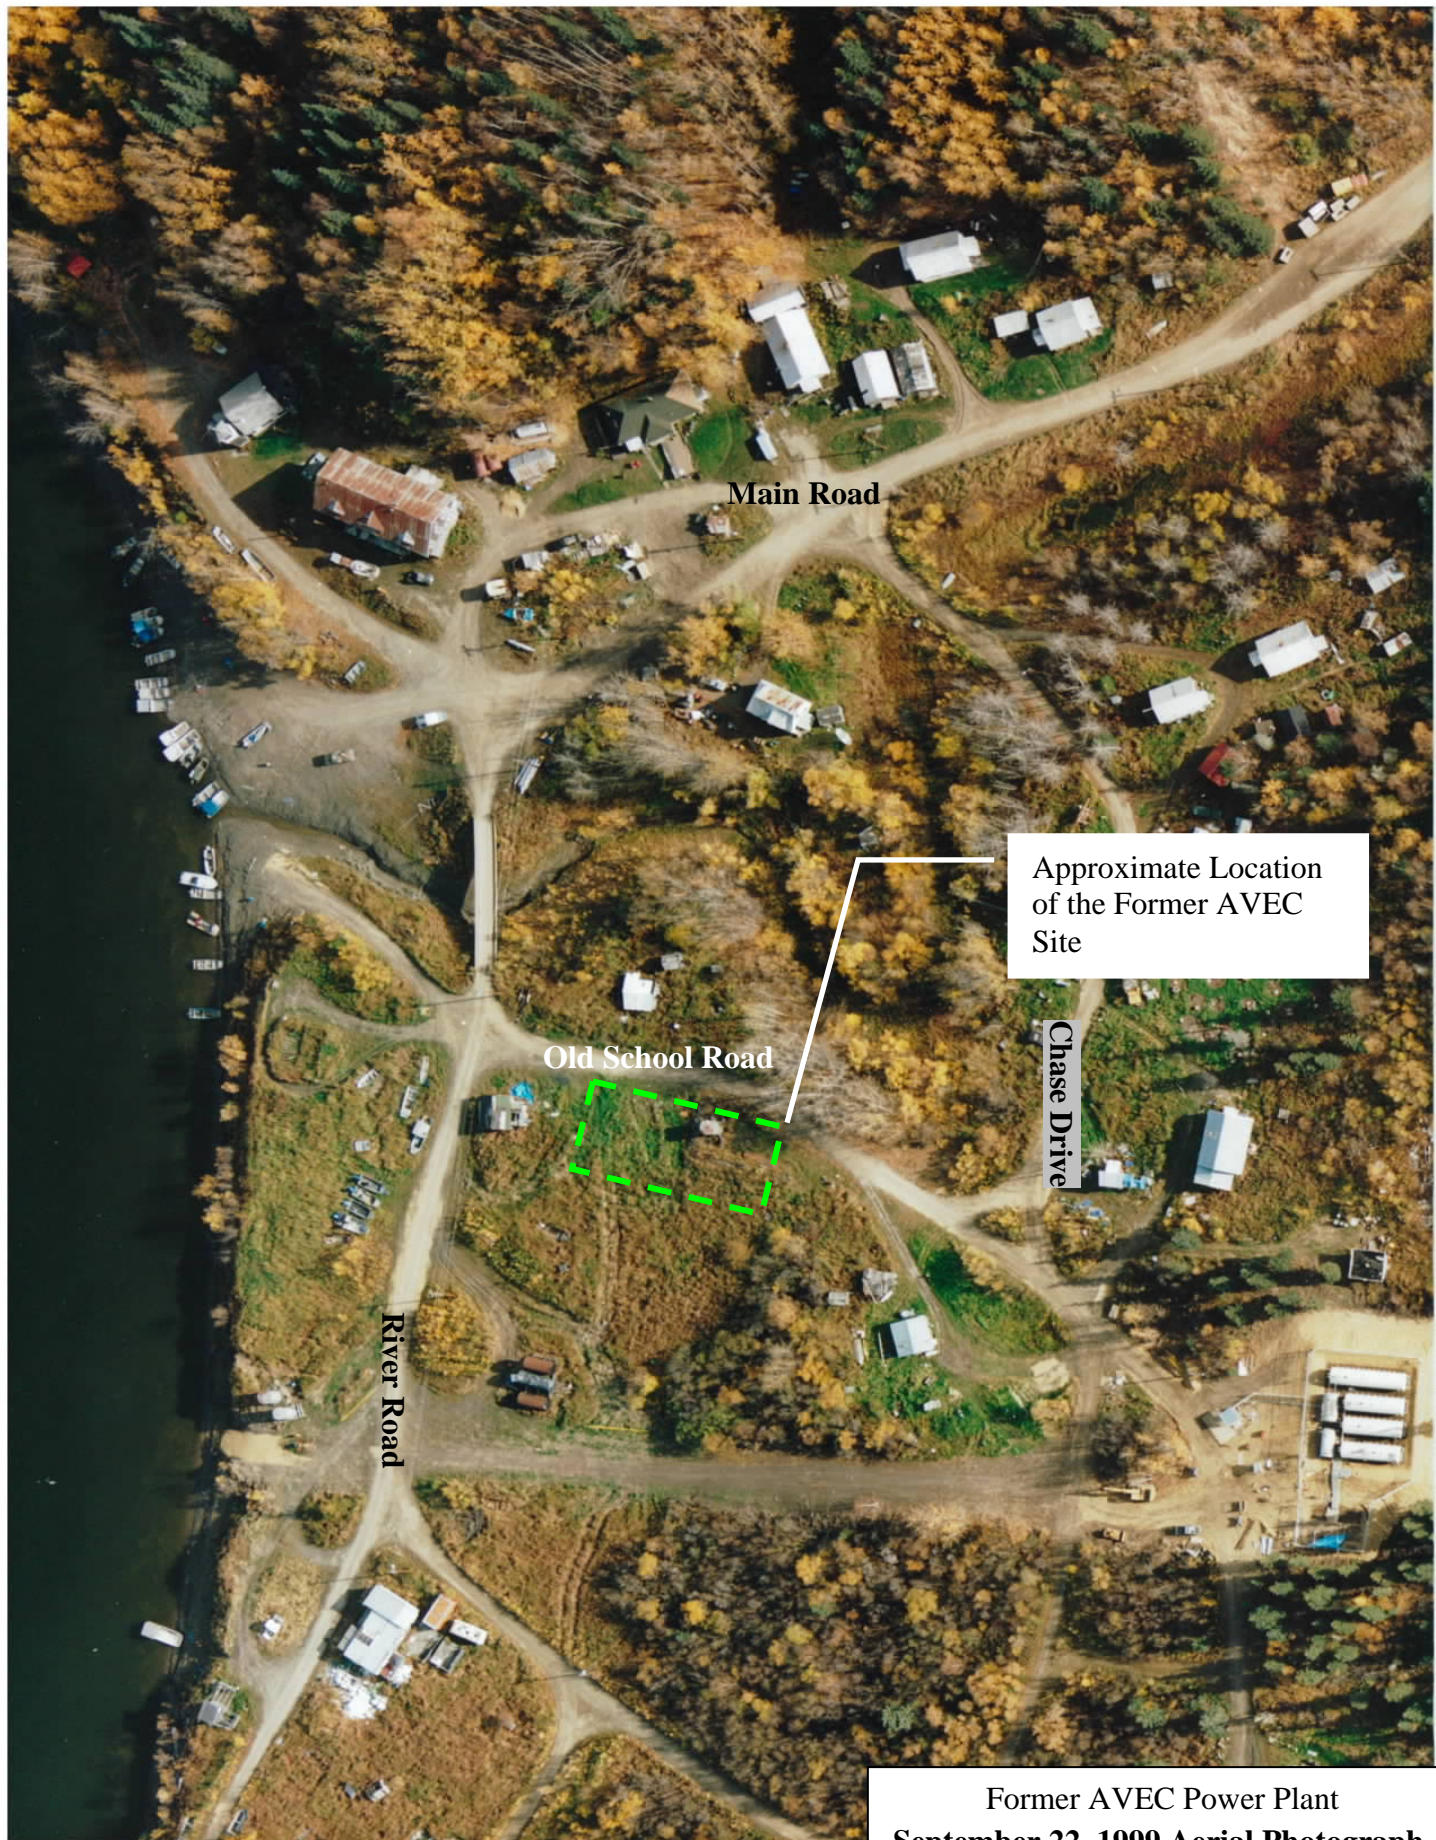
Former AVEC Power Plant September 22, 1999 Aerial Photograph		
BGES, INC.	October 2007	Figure 4

The September 22, 1999 aerial photograph, included as Figure 4, shows the subject property after the AVEC power plant was moved. There is no longer a generator building present on the subject
